SITE ASSESSMENT, REMEDIATION & REVITALIZATION

April 21, 2009

Summary of Supplemental Delineation Activities South Carolina Electric & Gas Company Huger Street Former MGP Site Columbia, South Carolina

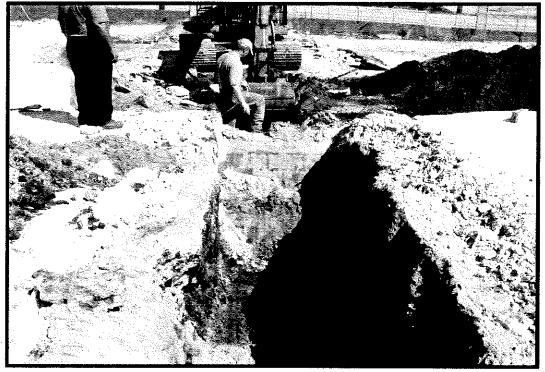
SDTP-2 and SDTP-3 were completed to satisfy the SCDHEC request for additional assessment in the former gas holder #1 area. From approximately ground surface to a depth of 4 to 4.5 feet bgs, above the former gas holder, impacts at both locations consisted of intermittent pockets of thick viscous to taffy like tar. At depths of approximately 11 to 13 feet bgs, at SDTP-2 and the eastern portion of SDTP-3, a black stained clay, with sheens and a slight MGP odor were observed. The western portion of SDTP-3 exhibited no visual or olfactory MGP impacts.

Western portion of SDTP-2 showing buried gas holder base

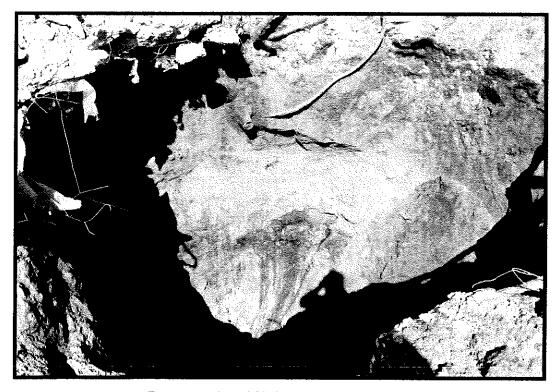
Eastern portion of SDTP-2 showing black staining

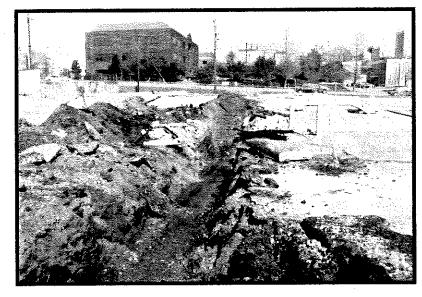
SDTP-3 central portion showing buried structure

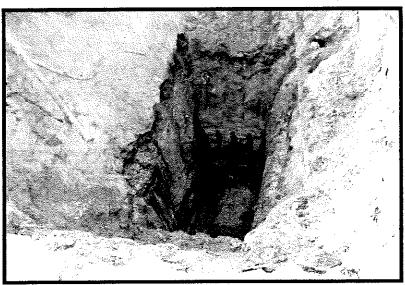
SDTP-3 eastern portion with black staining

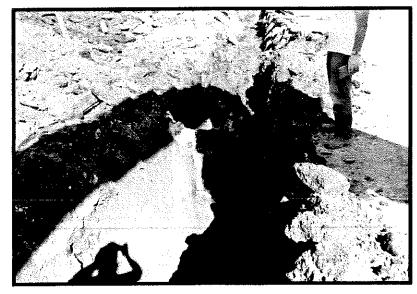
SDTP-3 western portion

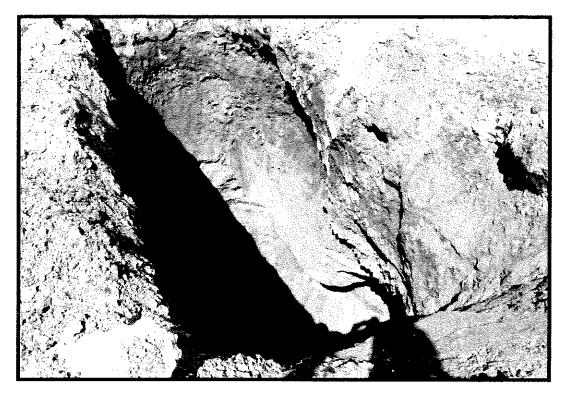
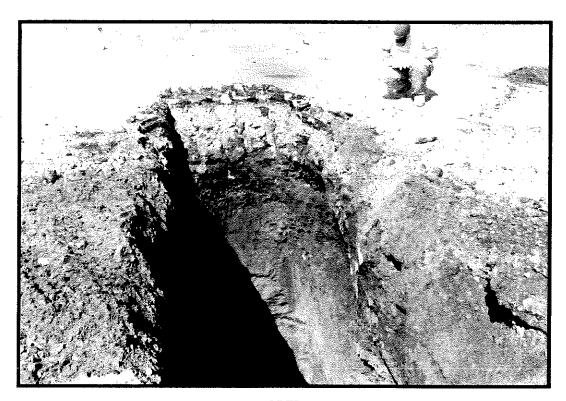
Along with SDTP-3, SDTP-4 was completed to satisfy the SCDHEC request for additional assessment in the area between soil borings M6, M7, M8 and M9. Conditions at SDTP-4 consisted of staining, with moderate diesel-like odors from 8.75 to 14.5 feet bgs, directly above the saprolite confining unit.

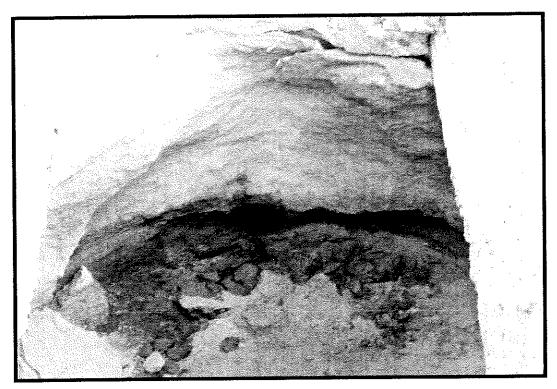
Test pits SDTP-5 through SDTP-7 were completed to satisfy the SCDHEC request for additional assessment in the former tar well and oil tanks area. At SDTP-5, several brick and concrete structures were encountered to depths of approximately 7 feet bgs. Impacts consisted of black staining from 10.5 to 15 feet bgs. Black stained clay was also observed from 15 to 16 feet bgs, but sidewall cave-in prevented further advancement of SDTP-5. SDTP-6 was without impacts to a depth of approximately 10 feet bgs. Below 10 feet bgs, the impacts observed graded from black staining to partially saturated with NAPL, to saturated with NAPL. The test pit excavation was terminated at 18.5 feet bgs, due to significant groundwater accumulation. At SDTP-7, three cylindrical concrete structures were observed at a depth of approximately 6 feet bgs. These may have been the foundations/footers of the former oil tanks. Impacts consisted of black stained sand and gravel partially saturated with NAPL from 10.5 to 17 feet bgs.

SDTP-5 black staining

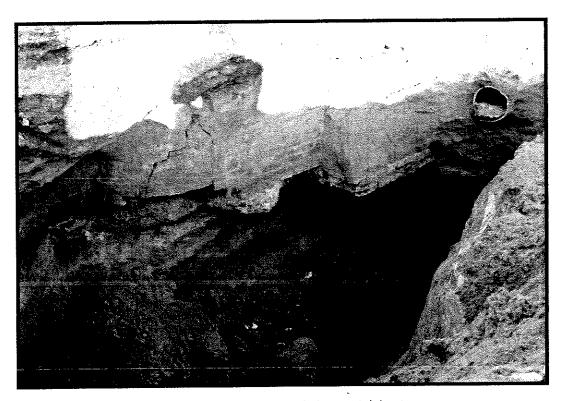
SDTP-5 brick structure and pipe containing tar

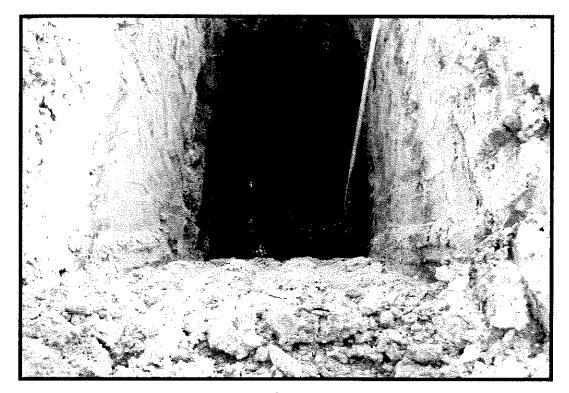
SDTP-6

- Material conditioning to render saturated material suitable for transport and disposal will most likely be required, to some extent;
- The bulk of the impacted source material is located within the saturated zone under the former bus maintenance facility structure (SDTP-6 and SDTP-7);

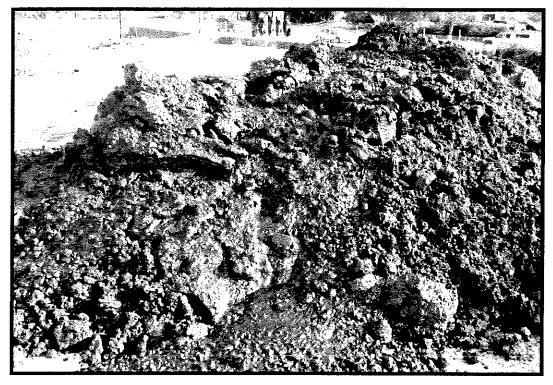
SDTP-6 NAPL saturated material

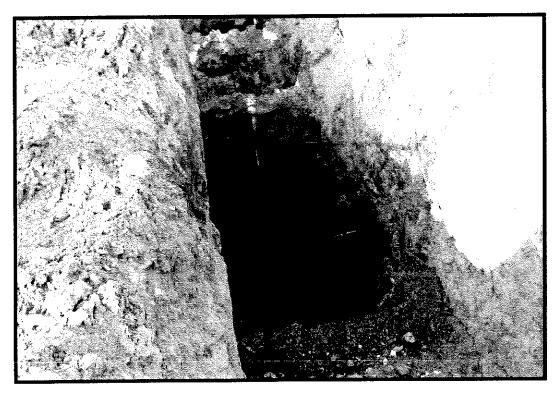
SDTP-7 concrete structure, NAPL, and black staining

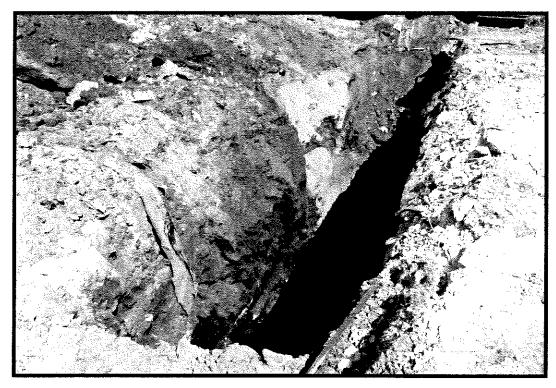
The rationale for SDTP-8 was to address a possible data gap between soil borings M-28 and M-16. Based on the test pit, a concrete and brick "floor" was encountered from 8.5 to 9.8 feet bgs, with the fill material above containing a black, silt and clay, with stiff weathered NAPL and blebs adhered to gravel from 6.3 to 8.5 feet bgs. Below the "floor", the excavated material consisted of slag, cinders, coal fines, and coal. Significant groundwater infiltration in this zone caused large amounts of sidewall cave-in, and the excavation was halted at 16.5 feet bgs.

SDTP-8 with NAPL blebs on gravel above concrete "floor"

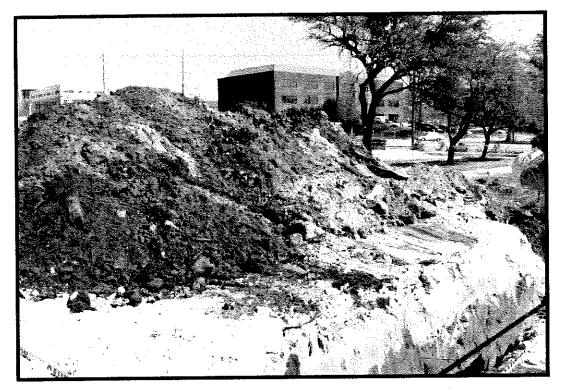
A previously existing office structure prevented past investigative activities in the area of SDTP-9. SDTP-9 consisted entirely of fill material, from ground surface to approximately 23 feet bgs, where the competent granite bedrock was encountered. From approximately 14.5 feet bgs to bedrock, the fill material was stained black, with trace to some NAPL blebs.

SDTP-9 material

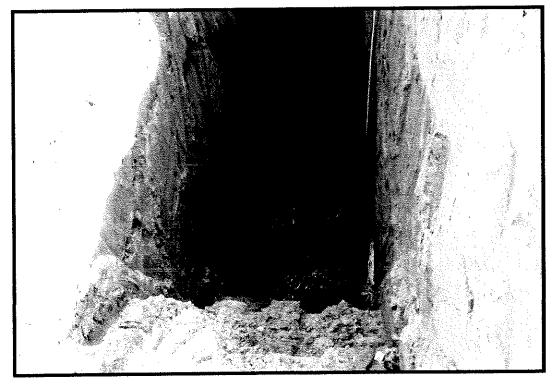
SDTP-9 excavation to bedrock

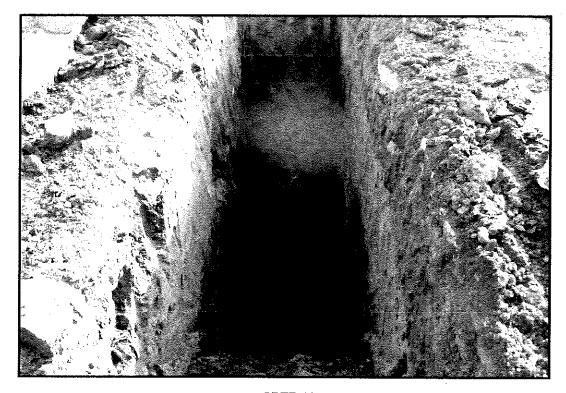
SDTP-10

Test pits SDTP-10, SDTP-11, and SDTP-13 were completed to satisfy the SDHEC request for additional assessment in the M17, M39, and M19 areas. Each of these test pits were composed entirely of fill material, with no visual or olfactory MGP related observations. Test pitting at all three locations was terminated when the excavator reached its maximum excavation depth, approximately 18 to 20 feet bgs.

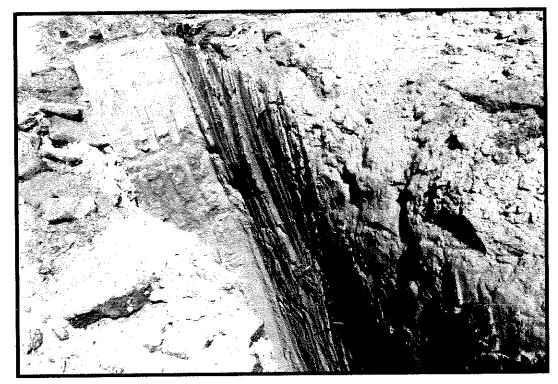
Test pits SDTP-12 and SDTP-14 were completed to satisfy the SDHEC request for additional assessment in the M37 and M29 areas. Both SDTP-12 and SDTP-14 were composed of fill materials and terminated at the excavator's maximum excavation depth. At SDTP-12, black staining was observed with a slight petroleum odor from 18 to 19.5 feet bgs. At SDTP-14, the interval from 7 to 9 feet bgs was stained black and had a slight petroleum-type odor.

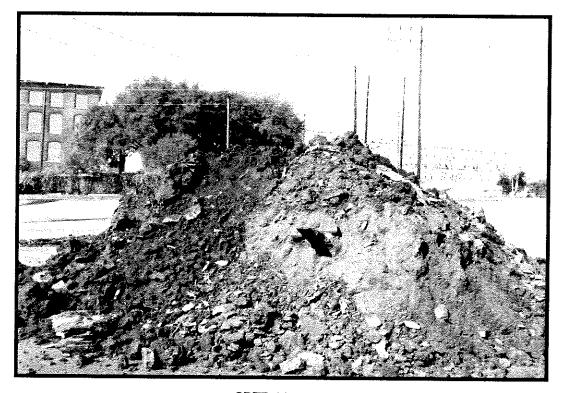
SDTP-14 material

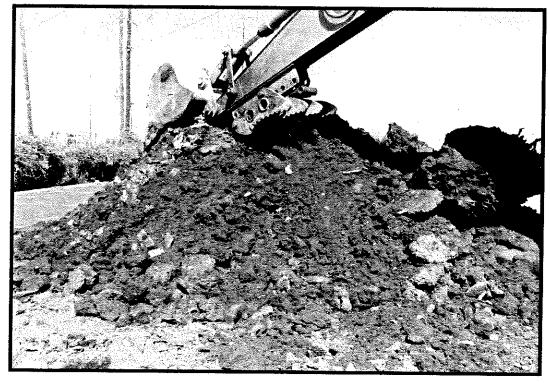
Test pit SDTP-15 was completed to satisfy the SDEHEC request for additional assessment between soil boring M31 and the southwest property boundary. Black staining, with a slight petroleum odor was observed from 17.5 to 19.5 feet bgs within fill material. The test pit was terminated at 19.5 feet bgs due to reaching the maximum depth capabilities of the excavator.

SDTP-15 material
